Former Plainwell Impoundment Time-Critical Removal Action Weekly Construction Update

Progress Report #59—August 11, 2008

Kalamazoo River Study Group
Allied Paper, Inc./Portage Creek/Kalamazoo River Superfund Site

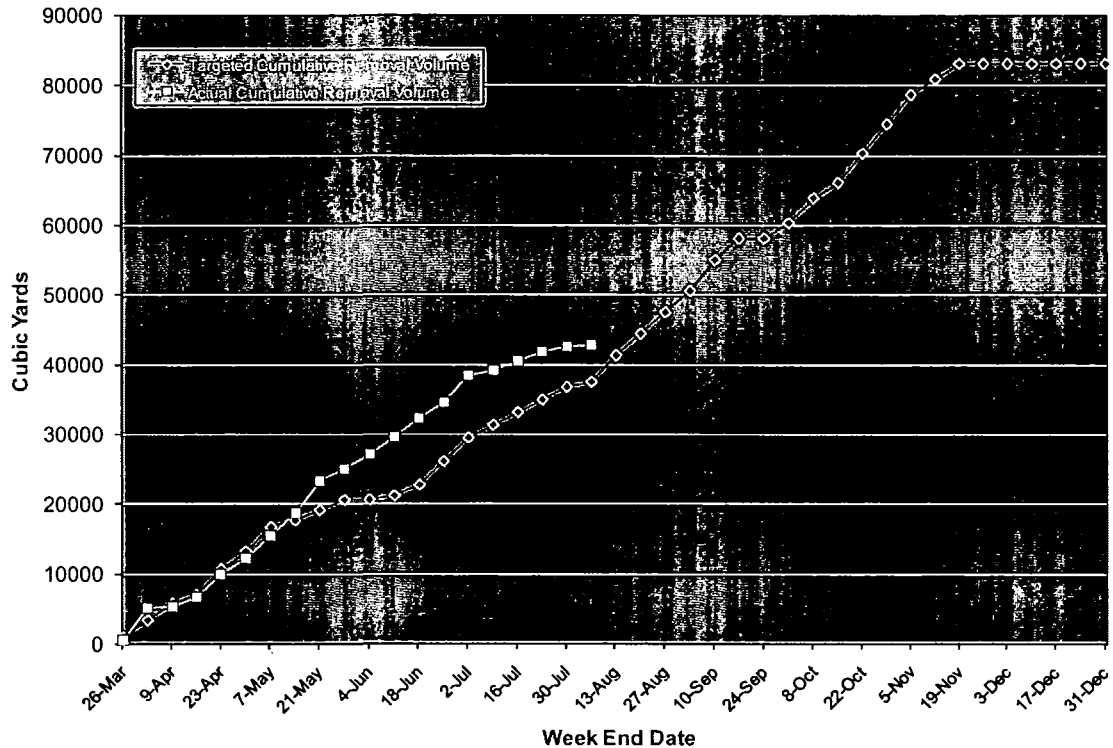
Removal Progress

Targeted volumes are neat and subject to change due to additional excavation done at request of USEPA.

Actual volumes removed below the targeted volumes potentially due to the conservative estimation methodology used to develop targeted figures and due to the actual topographic conditions encountered at the site, which could result in smaller volumes needing to be removed than originally estimated. The targeted volumes have been increased by 10% to account for additional material that could be removed as a result of over-excavation and additional removal in response to confirmation sampling. Soil/sediment removal activities are on schedule based on the ARCADIS BBL ES 4/30/07 Plainwell TCRA Construction Schedule.

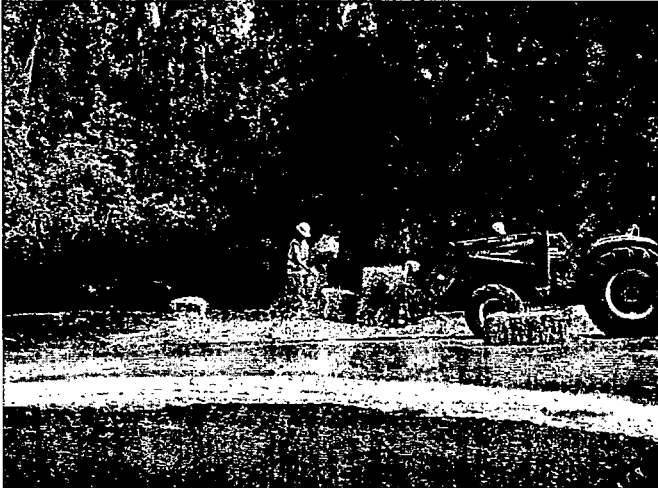
Performing post-deconstruction work in Staging Area 3S.

- Completed post-deconstruction in Staging Area 3S, including fine grading and topsoil placement.
- Continued removing soil and sediment from Removal Areas 11A and 12A.

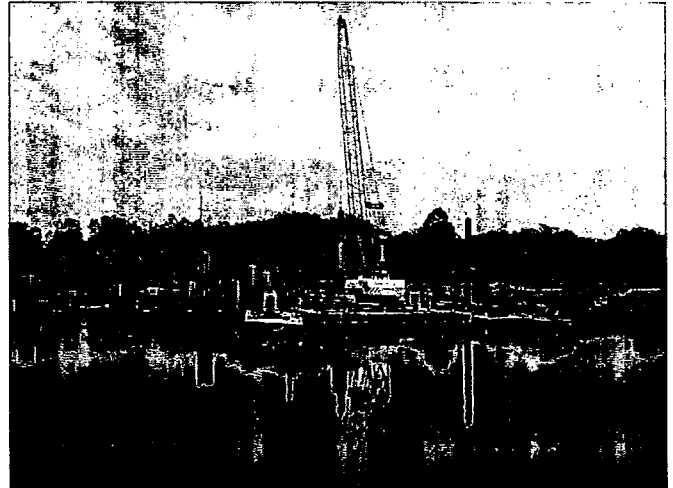
Installing steel sheeting for the Phase II Cofferdam.

- Continued loading and transporting solidified soil/sediment TSCA material from Removal Area 12A to EQ Wayne County Disposal Facility.
- Continued installation of the Phase 2 Cofferdam including a template wall and steel sheeting.

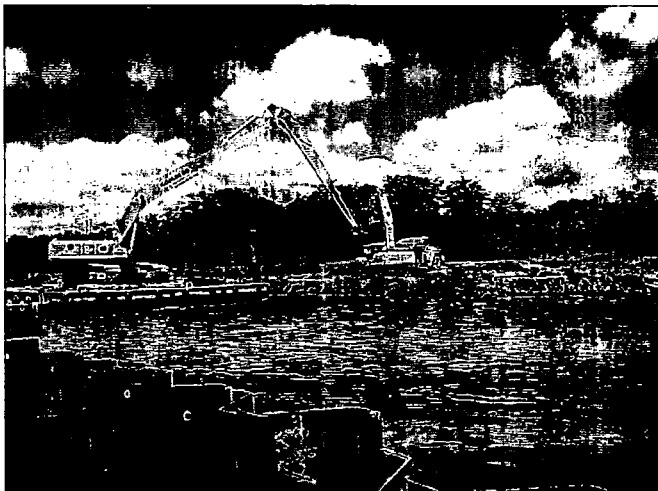
Excavating sediment from Mid-Channel B.

- Completed removal of sediment from Mid-Channel Area B. Excavation included the use of a long reach excavator (equipped with RTK GPS) on a portable floating barge system.

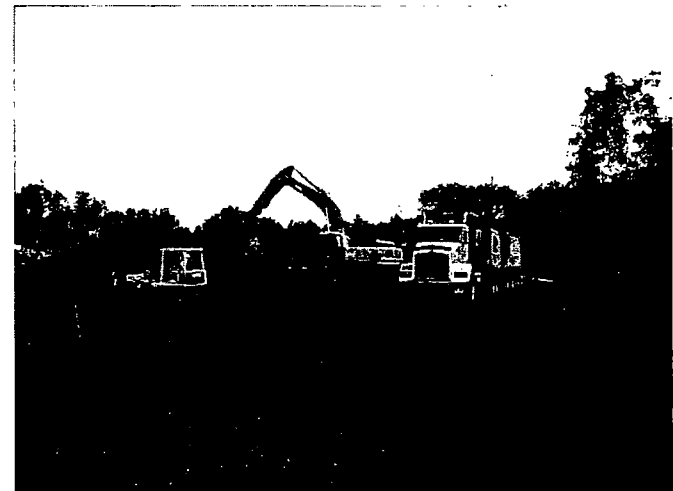
Loading stockpiled excavated soil/sediment from Removal Area 12A.
